András Kretz¹, Júlia Hornyacsek²

ADVANCED BUILDING ENGINEERING SOLUTIONS OF THE FACILITIES OF PROTECTION/DEFENSE ORGANIZATIONS IN THE LIGHT OF SUSTAINABILITY

1. WATER AND SEWER NETWORK

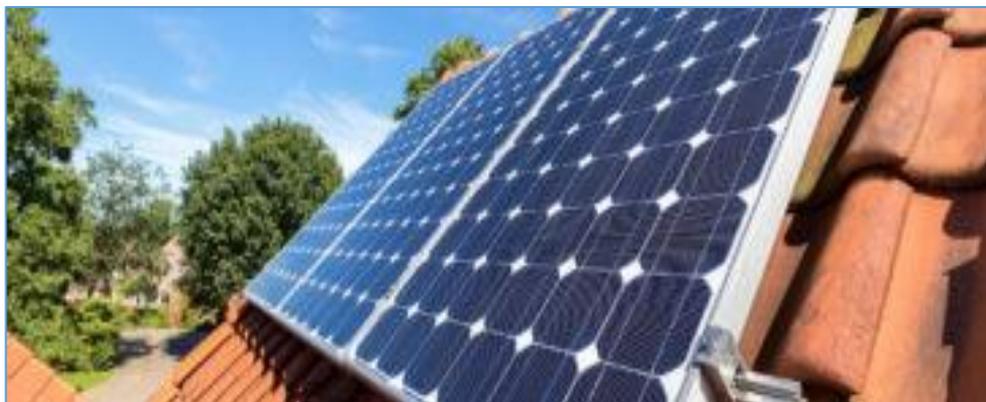
Photo 1. Producing energy using solar panels⁷

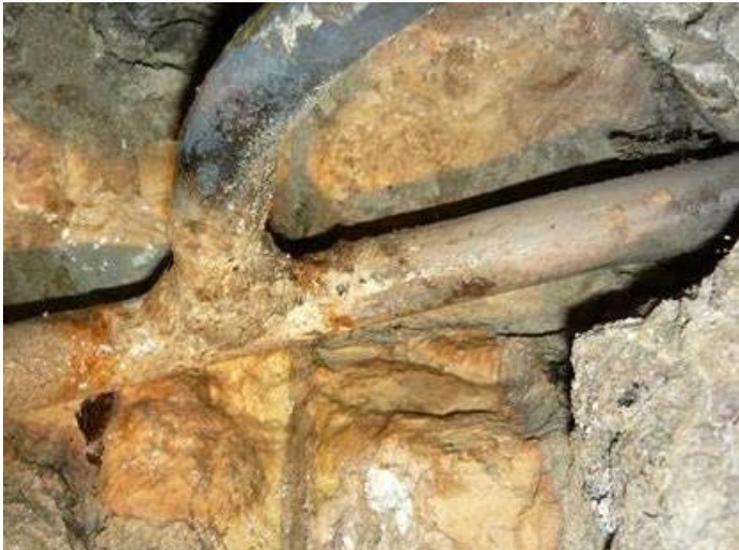
Photo 2. Exploration of worn corroded pipes in concrete-stone foundation

harmful effects of lead became known.¹² Corrosion-resistant materials have not yet been used for plumbing systems built around the 1950s and '60s, and as a result, some plumbing systems may require the replacement of the entire system. When a pipe is ruptured, it is often not possible to replace it completely, but the old pipeline has to be repaired, which is a big challenge to discover, weld and replace the faulty section.

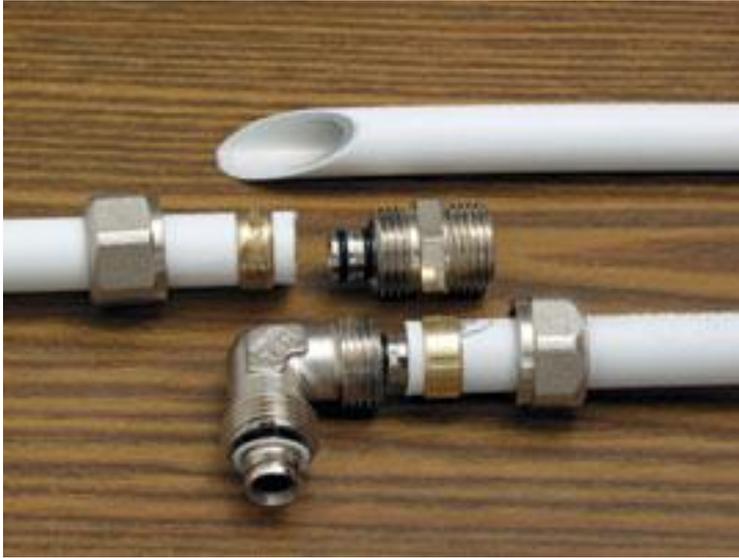
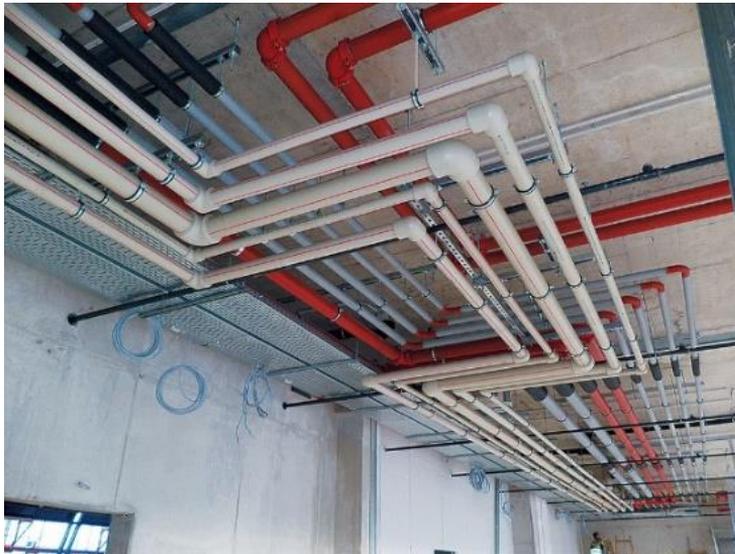
Photos 3-4. Plastic pipelines and an optional placement. Source:¹⁹

Many times, early detection and maintenance could have been a good solution, but without them, only replacements and thus prevention of greater environmental damage were possible. It would be advisable to increase the inspection of buildings with the possibilities provided by building diagnostics. Problems arising from use could be prevented by raising the awareness of appropriate methods as well as paying more attention. Damage caused by faulty construction or the use of poor quality materials is the most difficult to solve, so special attention should be paid to them when constructing new facilities. Plastic pipes are becoming more common, as well as alternative forms of pipe placement, such as driving them in the upper part of a room instead of breaking the concrete, if the type of building allows it.

However, it is not easy to replace the existing metal pipes during a renovation, the replacement by PP-R (polypropylene) or five-layer pipelines is justified by the data in the table below.

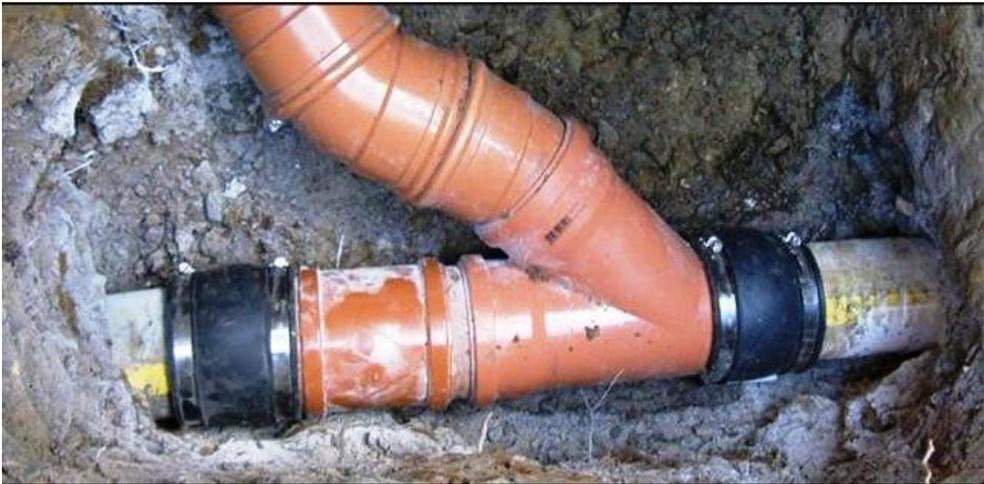
Photo 5: Sewage pipe repair. Source:²¹

Damaged pipes may require the replacement of a section or the entire length of the pipe. When replacing a section, it is recommended to use a solution with rubber sleeve joints, and an appropriate soil compaction and support.
